Kingpin Maintenance and Replacement Recommendations

July 8, 1994

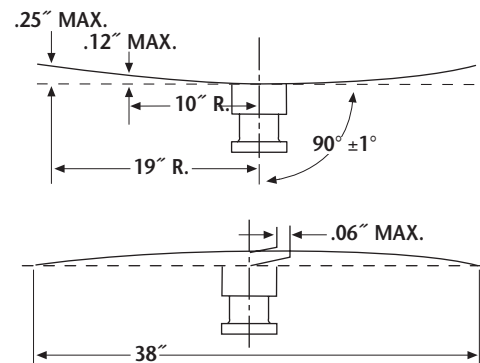
FIGURE 1

Using a 48" straight edge, check the flatness in all directions. Any bumps, valleys or warping will cause uneven loading of the fifth wheel, which could result in damage to the top plate and poor lock life. Replace the trailer upper coupler plate if flatness exceeds the specifications shown in *Figure 1*.

Using a square or Holland Kingpin Gage (TF-0110) check to see if the kingpin is bent. A bent kingpin accelerates lock wear and may interfere with proper fifth wheel locking. This also may indicate damage. The kingpin should be replaced if it exceeds 1° from square in any direction (see *Figure 1*).

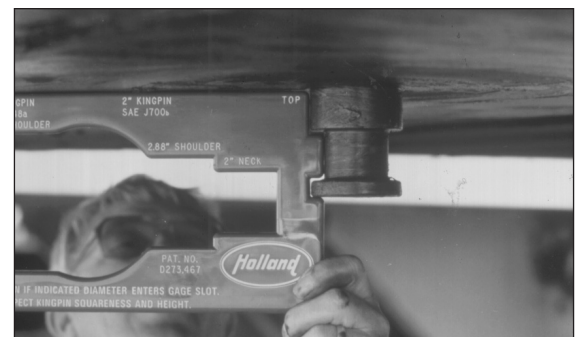
FIGURE 2

Using a Holland Kingpin Gage, check the length as shown in *Figure 2*.

If a lube plate is used in your operation, make sure to check the kingpin length. The kingpin must be sized to compensate for the thickness of the lube plate.

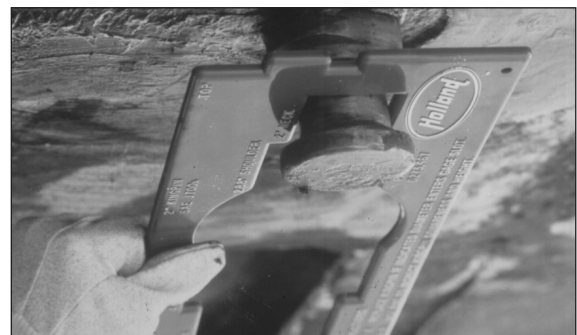
FIGURE 3

Using a Holland Kingpin Gage, check the wear on both the 2" and 2.88" diameters. Wear of 1/8" (.13") is indicated if the appropriate diameter enters the gage slot. Replace the kingpin if the gage slides into the appropriate gage slot (see *Figure 3*).
